Development of EMAT Sensors for Corrosion Mapping of UNGP Using ILI Tools

Project Final Report Public Version

December 2019

U.S. Department of Transportation
Pipeline and Hazardous Materials Safety Administration

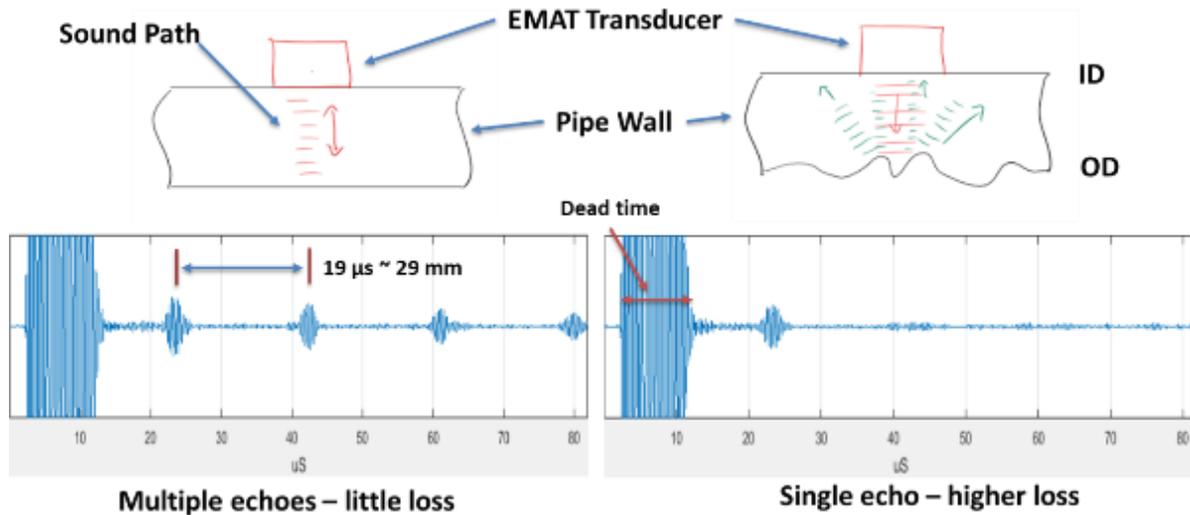
Figure 1 – EMAT A-Scan Responses for Two Different Scenarios: Clean Wall (left) and Corroded Wall (right)

One of the first aspects to consider during the development of an ultrasound-based inspection technology is the pipe surface topology. A rough surface can affect the acoustic responses in terms of signal scattering and ring-down. These issues are illustrated in Figure 1. The left side of the figure is an EMAT A-Scan from a thicker wall riser pipe section (roughly 29 mm), while the EMAT A-Scan on the right is an area where only one reflection from the OD wall was received. This is representative of what will happen if there is OD corrosion present. Instead of the ultrasonic sound energy reflecting directly from the OD surface back to the EMAT sensor, it scatters, reducing the probability of receiving multiple echoes. Worst case scenario is that the sensor does not receive any echo and a measurement cannot be made. The other issue illustrated in Figure 1 is the dead time or ring-down associated with the sensor. From the A-Scan on the right, one can estimate that the dead time is approximately 8 μs . The electronics driving this sensor was designed for thicker walls and for use in guided wave applications where the dead time is not of significant concern. However, for walls that are in the target range of 0.25" to 0.5", not including corrosion, this is a problem. For reference, the first reflection from the 0.4" wall will be around 6.7 μs and 2.0 μs for a 0.1" thick wall. If there is only one reflection received from the OD, excessive dead time will completely mask the measurement. The sensor must rely on multiple reflections to make a measurement. Multiple reflections are easily obtained on non-corroded surfaces or surfaces where the corrosion topology variation is much larger than the sensor dimensions. The key point is that the sensors ability to make measurements in corroded areas is the key evaluation criteria for an EMAT sensor. Although the lack of measurements in a corroded area of a pipe is information, it does not provide the information necessary to make any critical decisions. Typical dead times for commercially available EMAT sensors are about 4 to 5 μs , so the first echo would not be detectable for wall thicknesses less than approximately 0.3", the first echo would begin to blend into the ring-down and one would have to rely on additional echoes to make the measurement. This is only slightly smaller than a typical pipe wall thickness. In a situation where there is significant wall loss the sensor can only report "no reading".

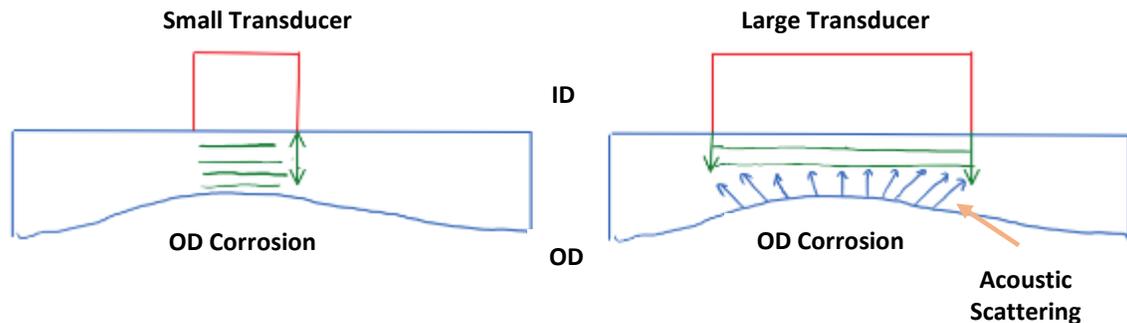
Figure 2 – EMAT Transducer Size Relative to the Corrosion Topology

One method to mitigate the lower amplitude signals caused by scattering is to reduce the size of the EMAT sensor. Figure 2 illustrates the situation. A large transducer may span a significant variation in the corrosion surface slope where the useful reflected ultrasonic energy is only from the corrosion peaks where the ID and OD surfaces are near parallel. The sloped areas reflect

energy away from the useful measurement direction. This scattering causes numerous issues; different path lengths causing blurring, mode conversion, shear wave polarization rotation, missed reflected energy, all of which reduce the reflected signal level and cause a blurring of return echoes. However, if the same energy can be focused in a smaller area, the percentage of the corrosion peak width (where it is the deepest) is a larger percentage of the transducer area increasing the probability of a good measurement. *The primary focus of a wall thickness tool is to obtain the minimum wall thickness.* EMAT's have traditionally required a large area to obtain good signal-to-noise ratios where the magnet diameter sets the area. The density of the magnetic field is limited by the magnets that are commercially available. Larger area transducers may be useful if the corrosion depth peaks are relatively the same height.

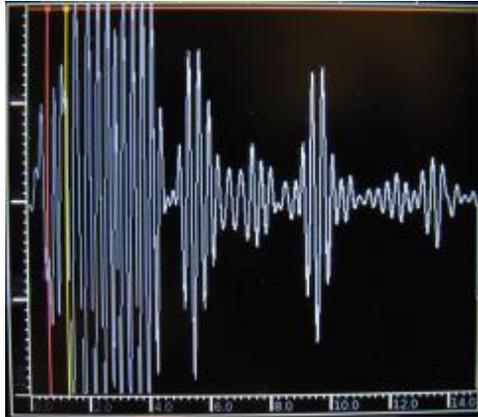
Figure 3 – EMAT A-Scan of 0.285” (7.2mm) Thick Sample with Severe Corrosion on Both ID and OD.

An EMAT A-Scan of the sample is shown in Figure 3 where 3 reflections can be observed. Other places on the surface would show no reflections or maybe only 1 reflection. The scale at the bottom is in microseconds and the actual thickness of the sample is 0.285". The EMAT electronics (commercial system) was damped to provide the short, $< 4 \mu\text{s}$ ring-down and the RF coil only has a 0.3 mm lift-off from the surface. Even though, we could obtain some useable reflections with our $\frac{1}{4}$ " sensor, a larger 1" sensor produced responses a bit more reliable. It was concluded that the larger area sensor covered enough area that there were sufficient non-corroded areas to obtain a signal however, this does not identify the deepest pit. We should point out that the A-Scan shown in Figure 3 was produced by our original $\frac{1}{4}$ " sensor, subsequent versions of the sensor would be improved and would like provide similar performance to the 1" sensor. The main point here is that there are surfaces that are difficult to measure regardless the technology.

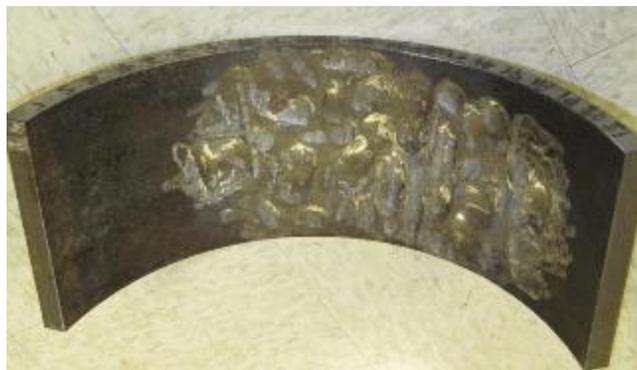
Figure 4. Simulated Corrosion Sample

Another sample has simulated corrosion on the ID and it can be observed in Figure 4. The EMAT sensors were tested from the OD of the sample. In this case, the topology of the corrosion is typically larger than the sensor footprint, so as expected, the sensors would receive thickness echoes from the bottoms of the corrosion pits. A qualitative comparison was made between the 1/4”, 3/8” sensors and a commercial sensor with a 1” footprint. EMAT A-Scans for these sensors at two different locations are shown in Figure 5. Clearly both smaller spot size sensors did a much better of finding pit bottoms as demonstrated by higher amplitude return echoes and multiple echoes. They found more locations in the sample with useable return echoes and when the same locations were tested with the large footprint commercial sensor; either a reflection was not found, or it was much weaker. It should also be noted that the commercial sensor has an artifact in the A-Scan. This could cause confusion in any post data analysis. Clearly the smaller footprint sensors have the capability of providing an improved Probability of Detection (POD).

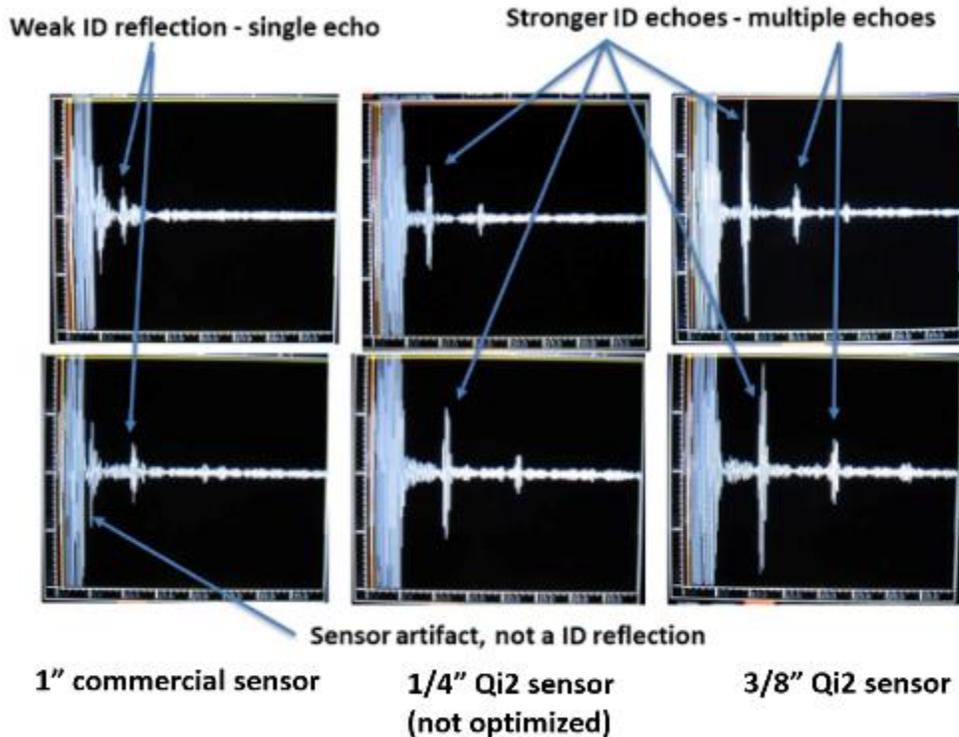
Figure 5. EMAT A-Scan Results from Two Pit Bottom That Could Be Seen by a 1" Commercial EMAT Sensor.
 Note: The gain was the same for all three images.

For demonstration purposes, a metal test sample was fabricated with a 3/8" wide flat bottom slot and a series of increasingly smaller round end-mill slots. The 1" commercial sensor could not really resolve any of the features while the 1/4" sensor could clearly resolve the bottom of the 3/8" slot and clearly see reflections from the bottoms of all but the smallest of the end-mill slot. The smallest round end-mill slot was approximately 4 mm wide at the surface and 1.25 mm deep at the apex. It was just visually notable in the A-scan.

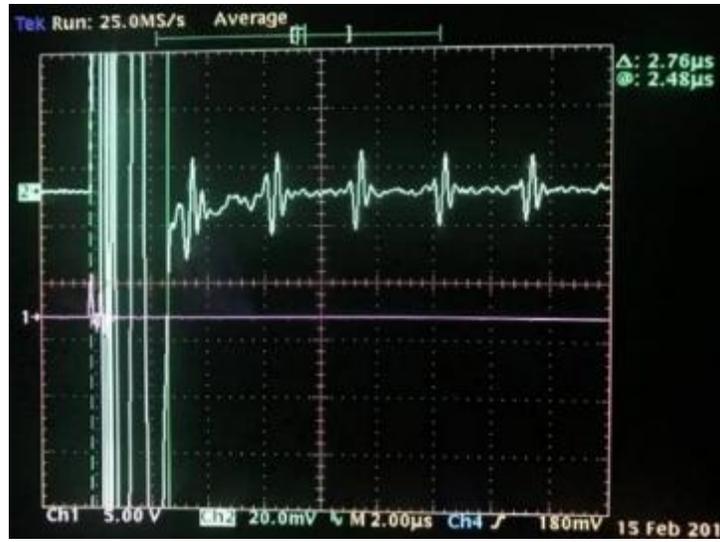
Figure 6. A-Scan from 3/16" Thick Sample Using the Optimized 1/4" Sensor

The oscilloscope screen shot in Figure 6 shows the A-Scan from a 3/16" thick sample using the optimized sensor and electronics. This uses a single cycle pulse from the pulser and demonstrates a wide bandwidth signal. The first return echo from the sample is clearly resolved. Of course, the multiple echoes show minimal decay because only a small amount of energy is lost at each interface reflection due to the large acoustic impedance mismatch and the clean surfaces.

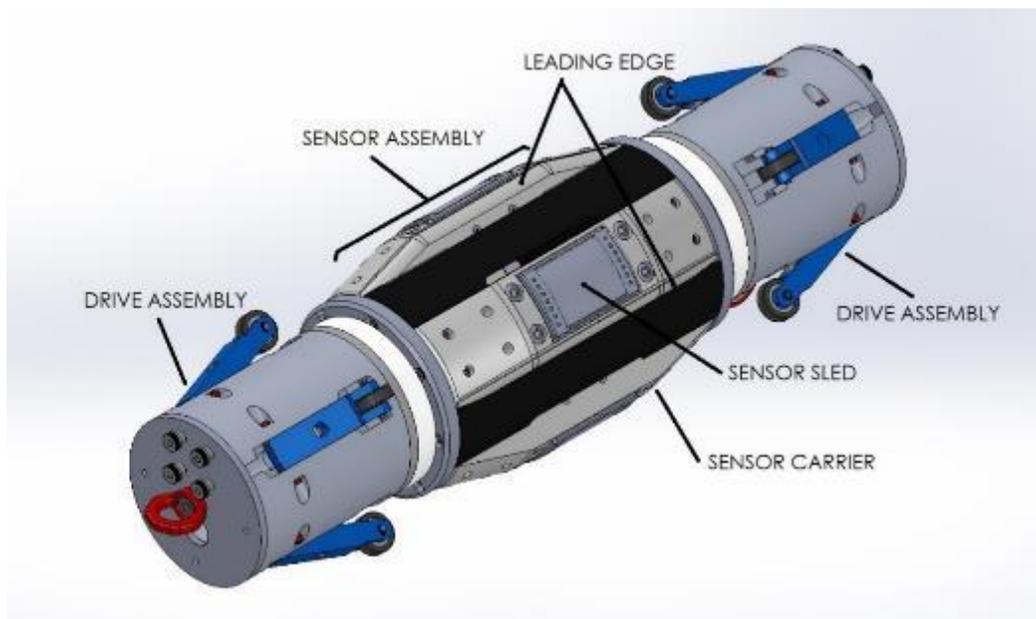
Figure 7. Bench-scale EMAT Sensor Module Design

A Solidworks™ design of the bench-scale sensor module is shown in Figure 7. The concept selected was more advanced than a bench-scale version that was originally proposed. The bench-scale device has two primary components: (i) the rotating sensor assembly, and (ii) the fixed drive assembly. The sensor assembly was positioned axially between two halves of the drive assembly. The extended wheel on the drive assembly prevents the overall tool from rotating.

Each of the four sensor carriers contains a single 3/8" EMAT sensor, so rotating at a constant rate using a fixed axial speed provides 100% coverage. Originally, we planned to have more than one EMAT sensor per carrier but decided it would have been too complicated to package the electronics at this stage of development. Each carrier was equipped with four steel ball transfers positioned to reduce contact and friction between the pipe wall and carrier body. Two metal shoes with threaded pivot pins were attached on each end of the carrier for easy access and mobility within the sensor assembly. The axial shape of the carrier has the proper curvature and size to accommodate 1D bends and intersecting pipes. One side of the carrier assembly (labelled leading edge) is sloped to protect the sensor sled from protrusions on the pipe wall. Essentially, the carrier will pull away from the surface along with the sensor sled if there is a protrusion.

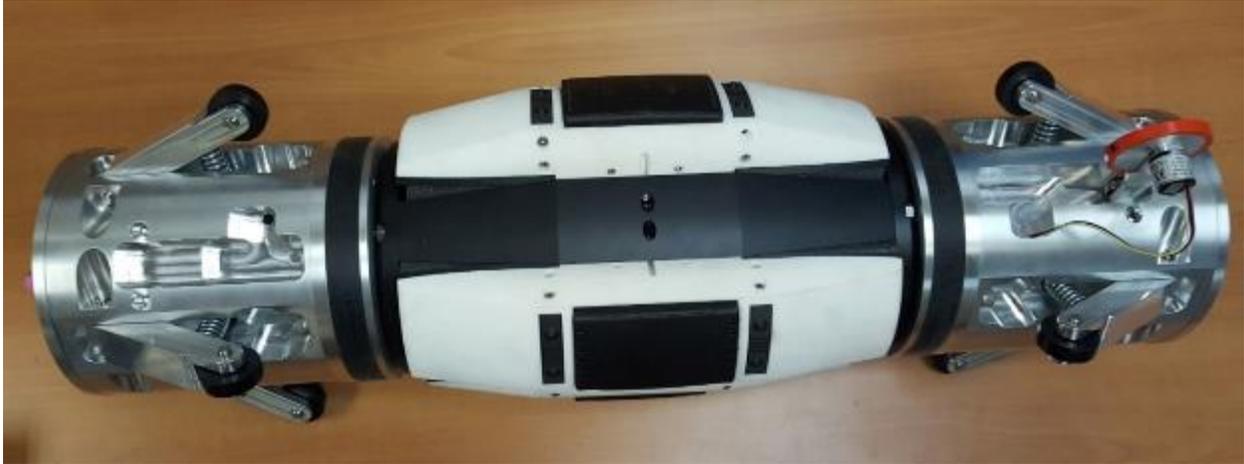
Figure 8. Assembled Sensor Module.

The bench-scale device was fabricated and assembled as shown in Figure 8. It can be observed that the drive/centering mechanisms are mounted on each end of the rotating sensor/electronics assembly. The extendable arms with the black wheels are used for centering and the red wheel is the axial encoder. Figure 9 shows photos of the drive end of the module with and without the motor assembly installed. The power and ethernet cables to the electronics are also shown. An ethernet rated slip ring was used within the module to bring power, ethernet and encoder signals in and out of the rotating sensor modules.

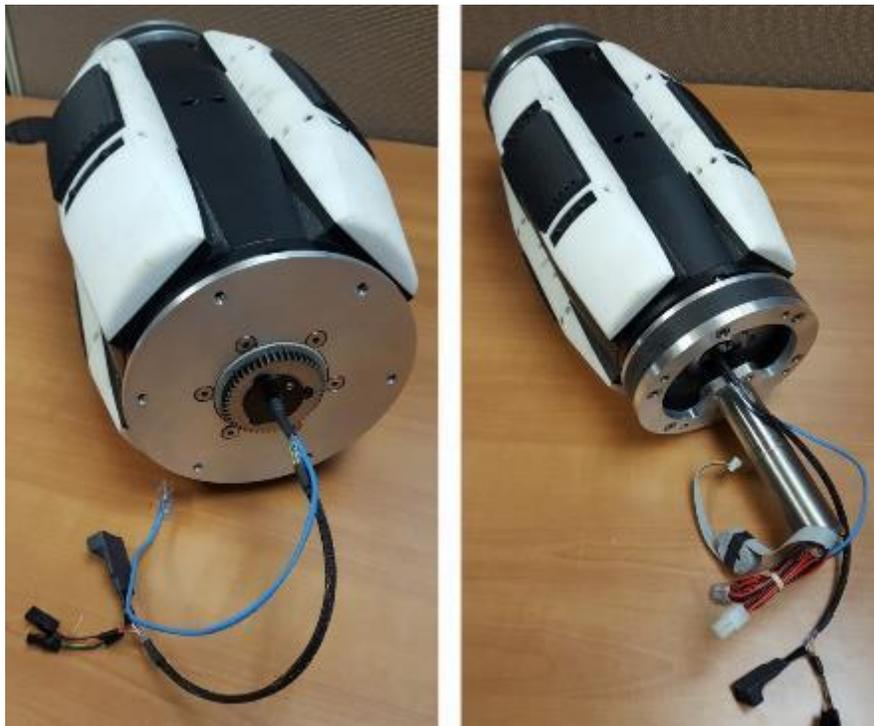
Figure 9. Drive End of the Sensor Module with the Drive Motor Assembly Installed (right) and Without (left)

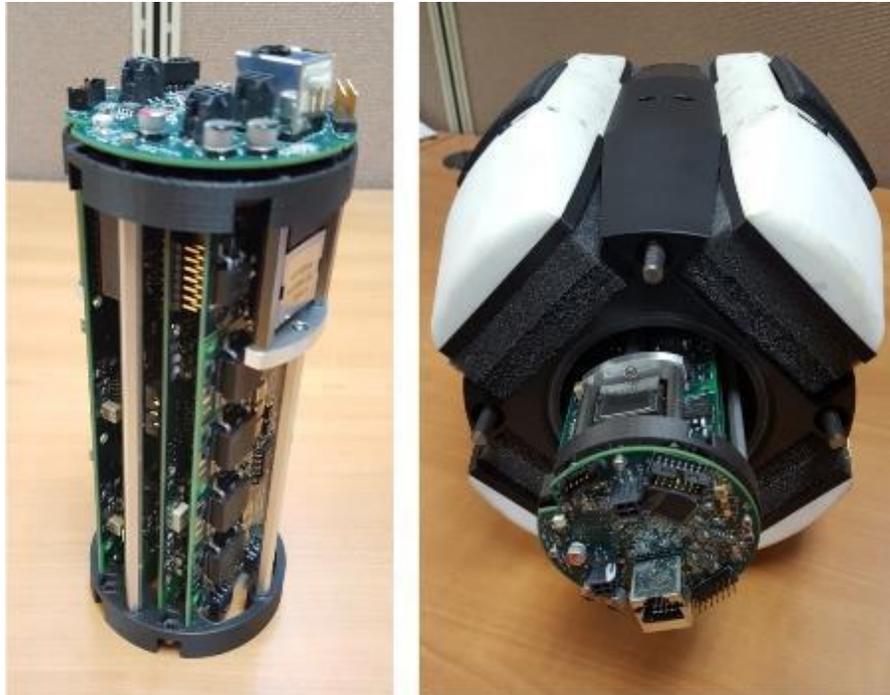
Figure 10. Custom EMAT Electronic Board Cage (left) and Partially Inserted Cage into The Rotating Sensor Module (right). Note the ethernet connector is protruding from the end.

The assembled tool electronics, i.e. a four channel pulser, a receiver and ethernet communications boards, are shown in Figure 10. The photo on the left is the cylindrical card cage assembly the fits in the center of the rotating portion of the tool. The photo on the right is the card cage partially inserted into the sensor module before the slip ring and drive components are installed.

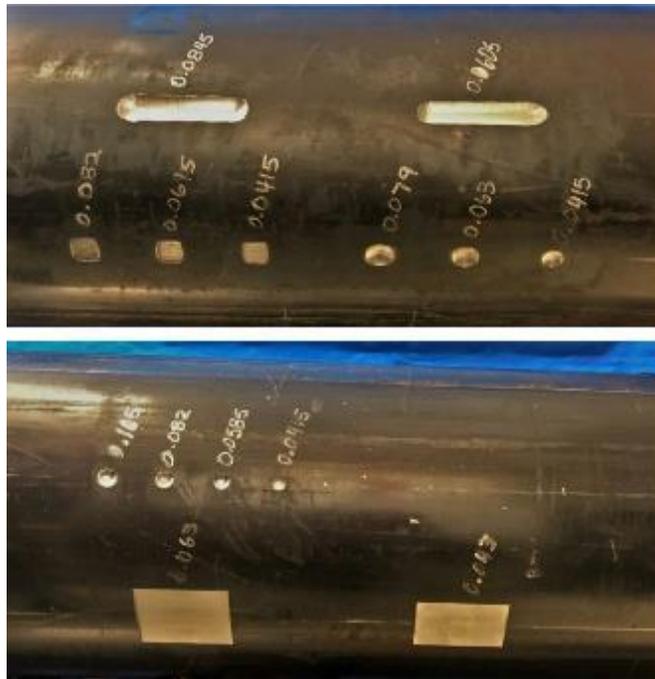
Figure 11. Fabricated Flaws – The Seam Is at The Bottom on The Top Photo and on The Top of The Bottom Photo

A test sample was fabricated from a short section of 8" schedule 40 pipe with a nominal wall thickness of 0.322". The sample is shown in Figure 11. Note that all the machined flaws in the pipe present a curvature to the EMAT sensor as opposed to machined flaw samples that have an extended uniform wall thickness over an area that would be easy to measure and detect, if they are the same size or larger than the 3/8" or 1/4" sensor footprint.

In the case of the slots or flats, the bottoms of the flaws are uniform in wall thickness only along a line along the pipe axis. For the small radius flaws the minimum wall is at a point. Two different ball-end-mills (1/4" and 1/2" radius) were used to create the rounded flaws. Detection of these flaws is particularly difficult because the energy is deflected away from the sensor at every location along the flaw other than at the single point where the surface is tangent to the sensor. The measurement is further complicated by the fact that the acoustic signal is created along ID radius that diverges the beam and then hits a flaw bottom that further diverges and blurs the signals.

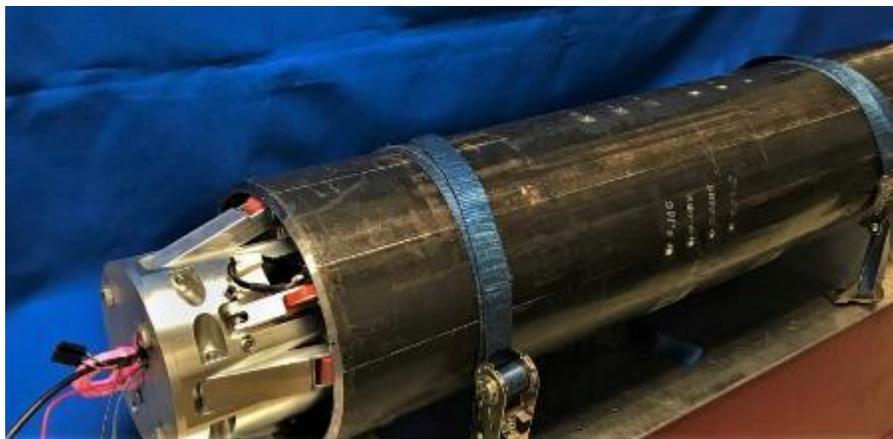
Figure 12. Test Setup with Bench EMAT Scanner Inserted

The bench-scale prototype was tested on the pipe of Figure 11 as can be observed in Figure 12. As mentioned before, the bench-scale prototype was fabricated with 3/8" footprint sensors as opposed to the 1/4" sensors. In retrospect, we probably should have used the smaller sensor, however the larger footprint sensor had slightly better sensitivity and we wanted to test to see how well the device could rotate four sensors with the greater friction. An EMAT C-Scan of the pipe section is shown in Figure 13. The seam runs through the center of the scan. The height of the C-Scan is approximately 24" (the circumference of the pipe), so the spacing between the thin red stripe representing the thicker part of the pipe around the seam is spaced approximately 1" from the yellow stripe.

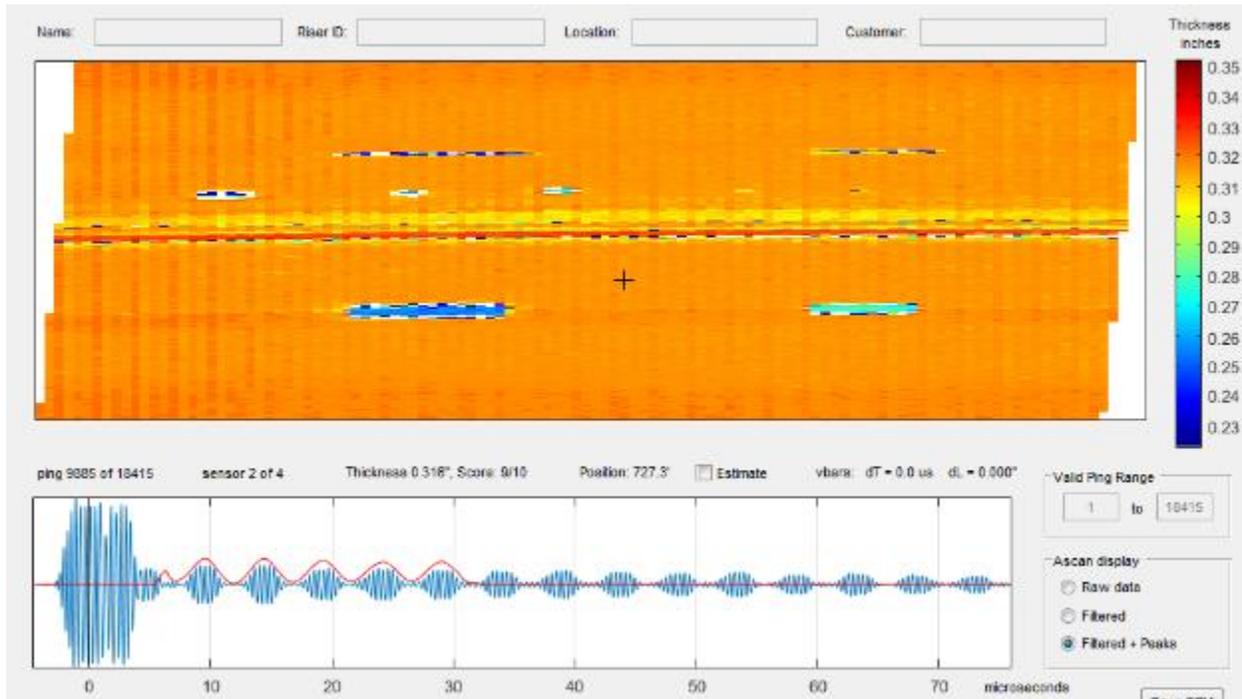
Figure 13. Pipe Section C-Scan and A-Scan Using Four 3/8" Footprint EMAT Sensors

Note how thin the red stripe is, as well as the orange stripe between the yellow and red stripes. This demonstrates the high spatial resolution of the 3/8" sensor. The 2" long machine flats were clearly resolved. They appeared as different lengths because the tool's axial speed was not uniform. The end mill slots were also resolved. Note that the ends of the C-Scan are stepped due to the 4 individual sensors, which are offset circumferentially around the pipe ID.

The 1/2" square flats were also detected with some radius readings. The two deeper 1/2" round bottom holes were detected too. The four small 1/4" round bottom holes were not detected. However, their signature can be found in the data set as a reduction in signal amplitude. This could be used as a detection method to determine when the data analyst should review the A-Scan. Essentially the automated processing significantly reduces the amount of data that the analyst must review.

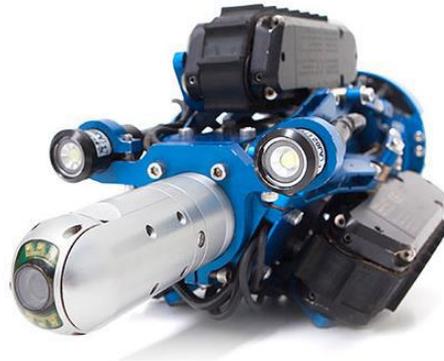
Figure 14. Inuktun Services Ltd. VT100 Vertical Crawler

The specialized VT100 vertical crawler module provides centering within the pipe as well as superior traction for forward/backward motion. The EMAT sensors were mounted on a separated cart. This carrier was designed to first expand the sensors against the pipe wall and then to rotate the whole module during the scan process.

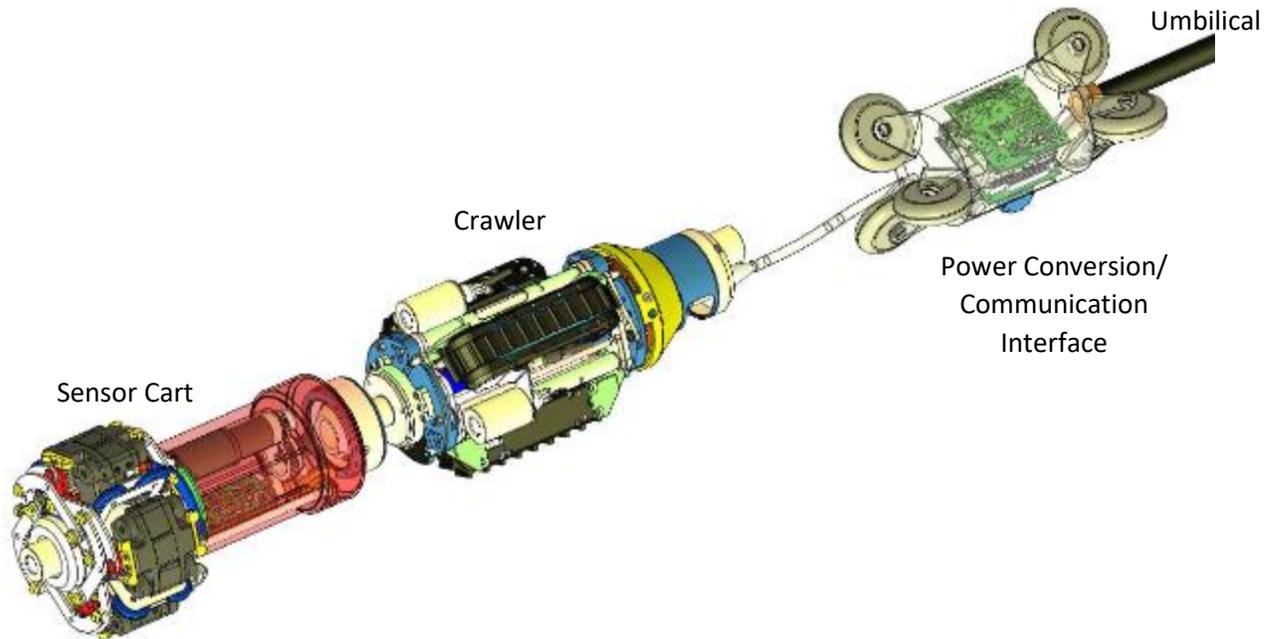
Figure 15. Initial Robot System Design Concept.

The conceptual EMAT cart design was sized for an 8" to 12" pipe. Larger pipes would require a scaled-up version of the expansion mechanism and a modified version of the EMAT sensor cart for the larger radii inner surface. The trailing electronics cart houses the power conversion and distribution, fiber optic terminations, video and communication electronics. A fiber optic and power umbilical connected the robot to a computer and power supply (base station). A sketch of the initial design is illustrated in Figure 15.

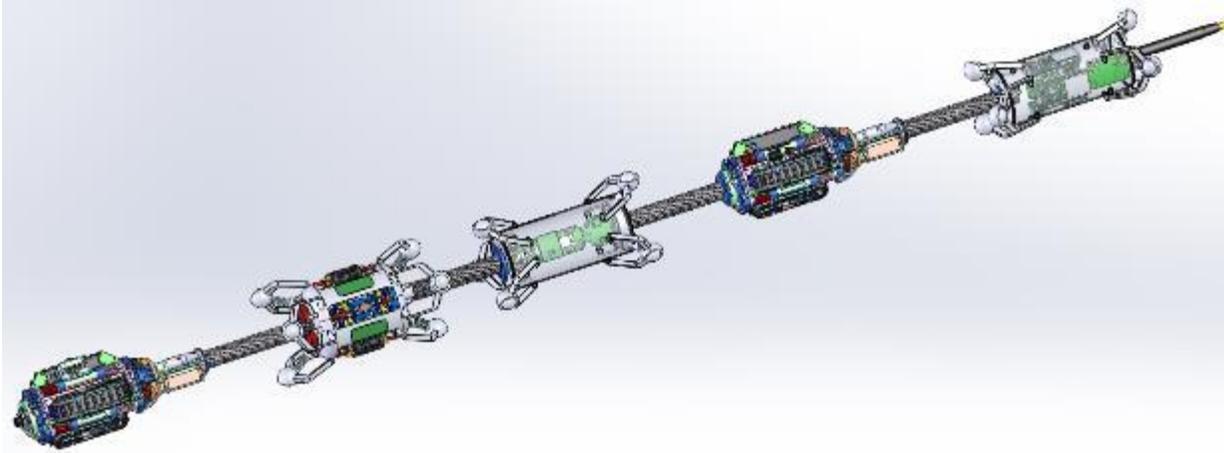
Figure 16. EMAT and PEC Crawler Concept

Based on the new information, the robot system was redesigned for integration of two PEC sensor within the sensor module along with the necessary space to house the associated electronics. It is important to note that due to the effort required to develop a smaller PEC sensor head, it was not integrated on this project as is not part of the contract. In addition, the redesigned provided better navigation of the sensor module through the bends. The goal is to attain as least PEC measurements in the bends. This design reduced the number of EMAT transducers from 4 to 2. The redesign is shown in Figure 16.

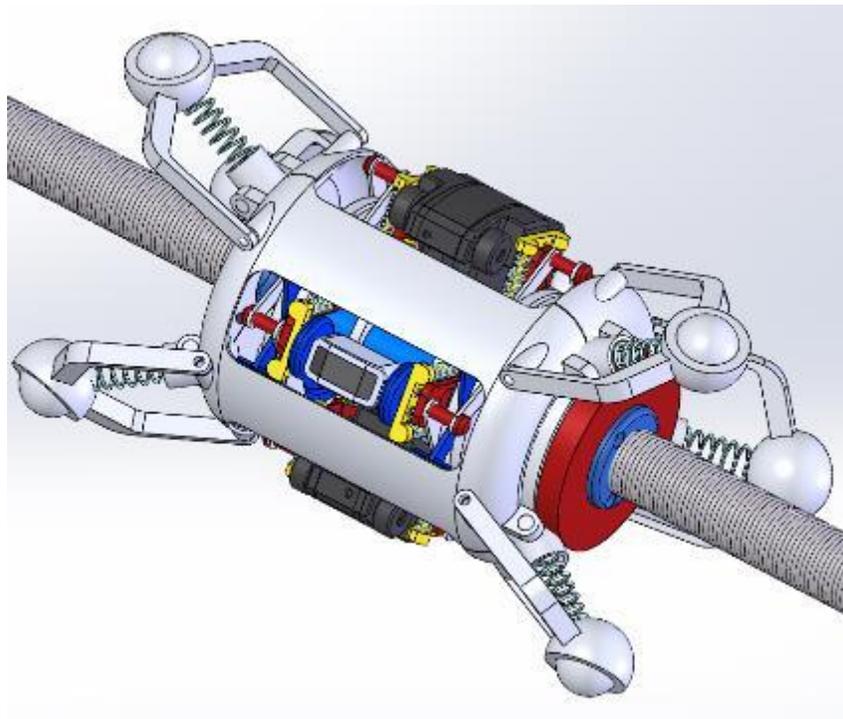
Figure 17. EMAT/PEC Sensor Module

The modules are interconnected with electrical conductors running inside flexible springs. The crawler modules expand to the pipe walls to provide motive traction. The remaining modules are centered using spring loaded linkages and castor style rollers. The sensor electronics module and EMAT/PEC module rotate in unison – driven from a micro controlled motor contained inside the EMAT/PEC module. This eliminates the need for a slip ring between the electronics and the sensors. The EMAT/PEC module also contains a motor to expand and contract linkages which bring the sensors in contact/proximity to the pipe wall. A detailed view of the EMAT/PEC sensor module is illustrated in Figure 17.

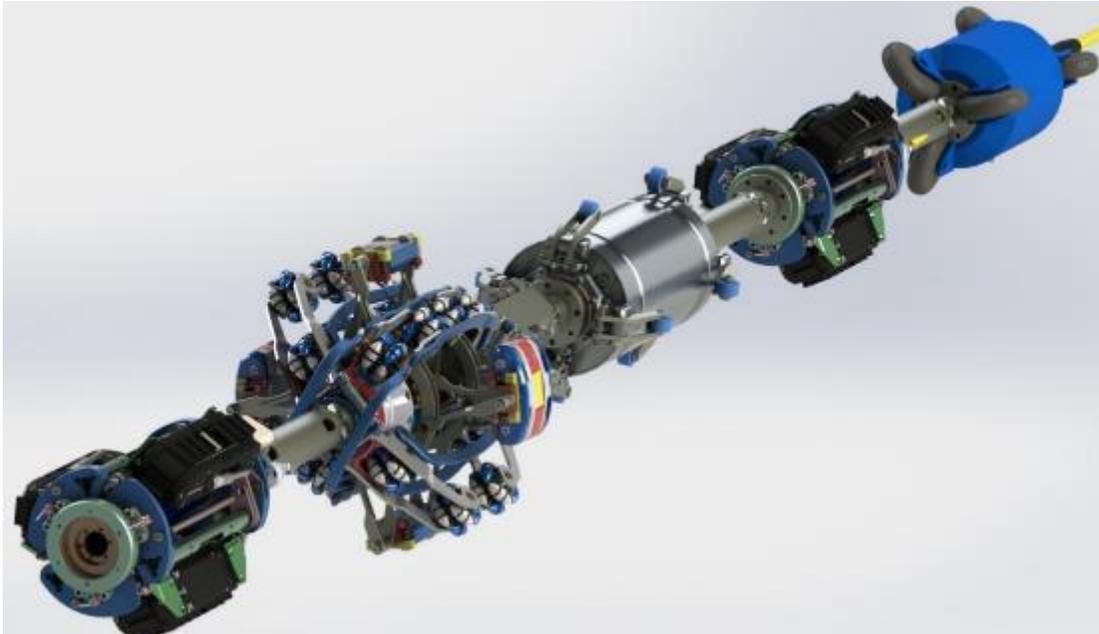
Figure 18. Refined EMAT/PEC Crawler System Design

The EMAT/WT Robotic system design was further detailed, in particular the EMAT/PEC crawler mechanical design was improved. The resulting design for manufacturing is shown in Figure 18. In particular, the wheeled system on the vehicle and sensor electronics modules were updated to ensure a better ride and contact along the pipe. A detailed view of the sensor electronics module is depicted in Figure 19. The EMAT/PEC crawler and Sensor Electronic modules as well as two EMAT sensors were fabricated and assembled for testing as shown in Figure 20.

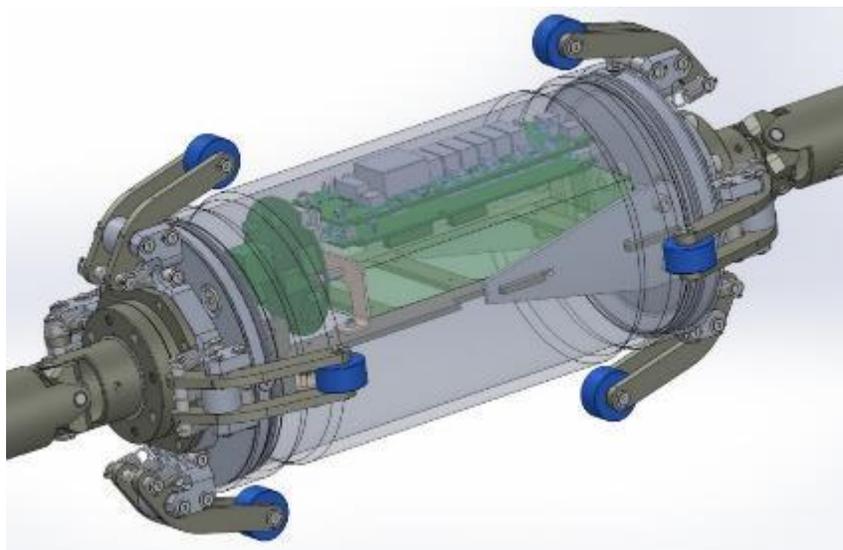
Figure 19. Sensor Electronics Module

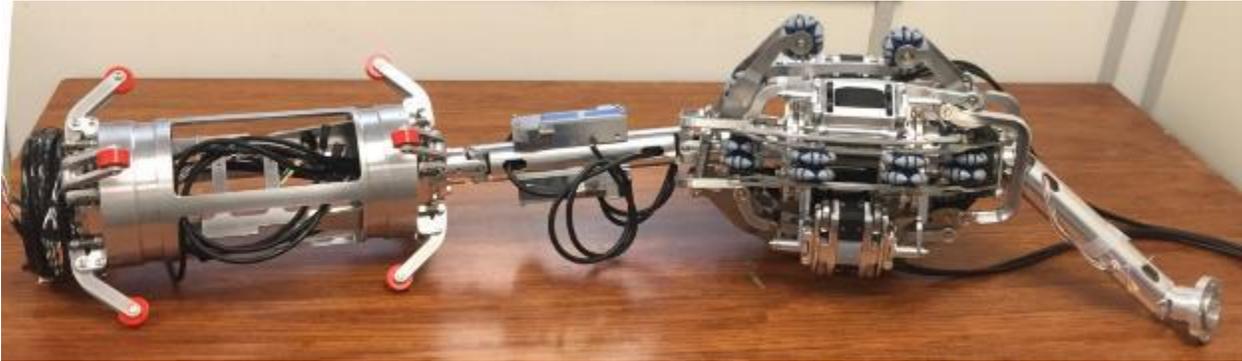
Figure 20. Assembled EMAT/PEC and Electronics Sensor Module

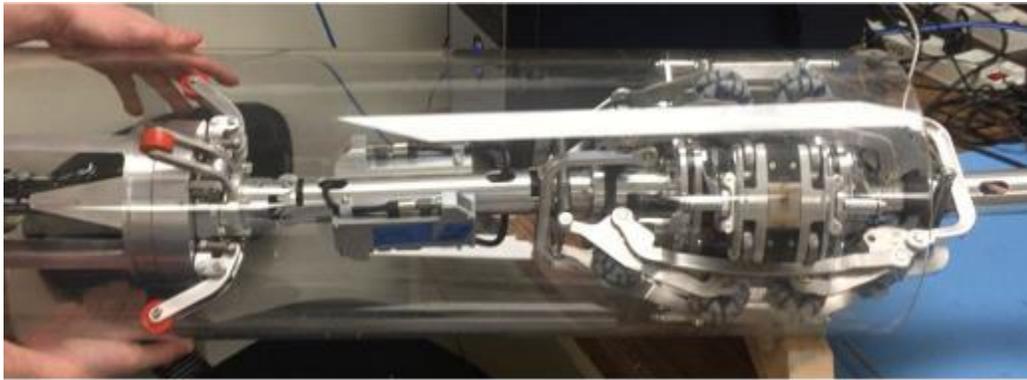
Figure 21. Images of the EMAT/PEC Sensor Module Rotation inside of an 8" Acrylic Pipe.

The EMAT/PEC subassembly was powered up by Inuktun to assess its performance. The device was tested inside an 8" acrylic pipe for rotation (Figure 21) and on an 8" steel pipe for extension/retraction and rotation (Figure 22). During these testing sessions, Inuktun identified some interferences between parts, the motors needed to be upgraded and the centering mechanism optimized.

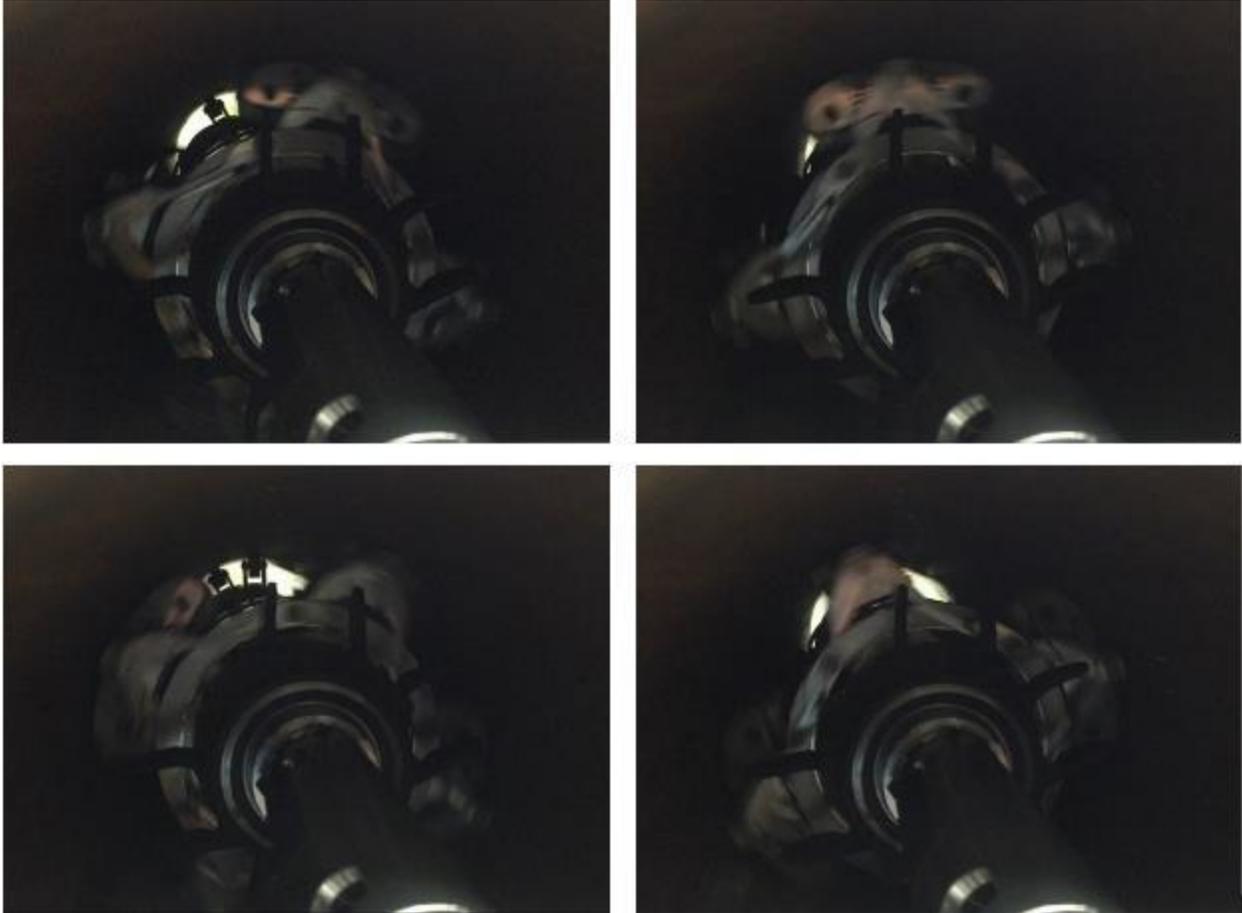
Figure 22. Views of the EMAT/PEC Sensor Module Rotating inside an 8" Steel Pipe

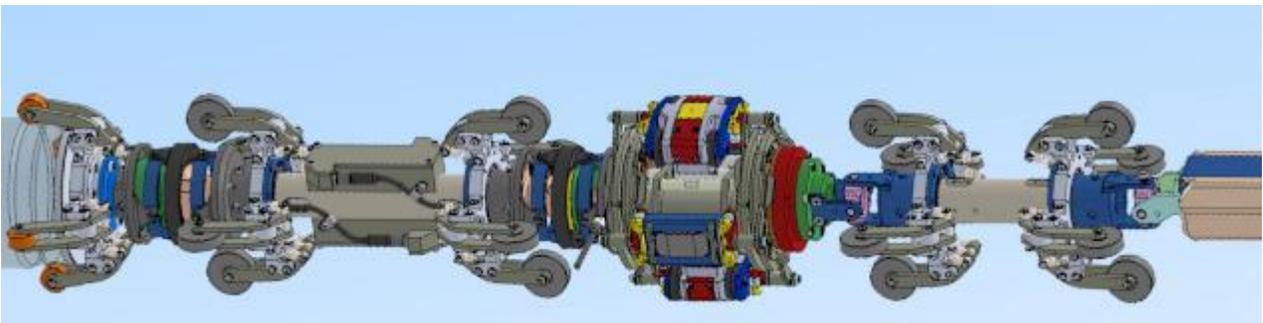
Figure 23. Optimized Centering Mechanism for Scanner

Based on the testing feedback, the scanner centering mechanism was revised as illustrated in Figure 23. It is important to note that the system underwent four major redesign efforts to ensure the EMAT sensors performed as expected. The system was finally fabricated and assembled.

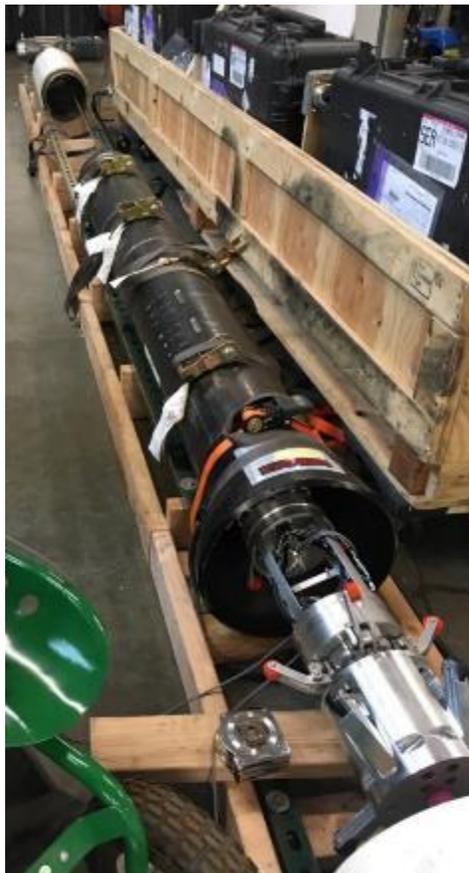
Figure 24. EMAT/WT Subsystem Connected to a Handheld Data Acquisition Unit

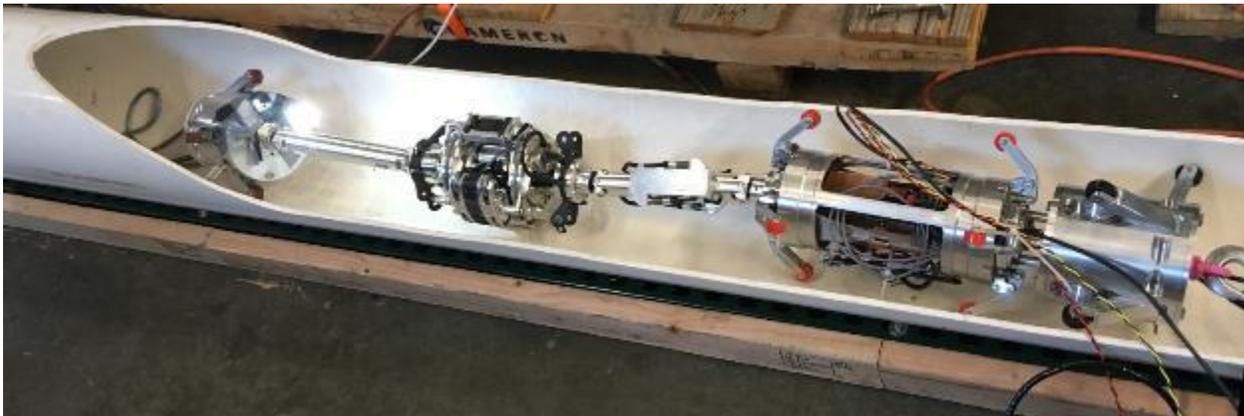
Figure 26. System on Testing Fixture

The EMAT sensors were integrated into the Sensor Module for signal evaluation. The extension/retraction and rotation mechanisms on this module were connected to a controller provided by Inuktun. The tool subassembly was setup inside an 8" diameter schedule 40 steel pipe as can be observed in Figure 24. Once in place, the extension/retraction mechanism was activated to push the EMAT sensors against the ID pipe surface. An image of an EMAT sensor near the pipe wall is shown in Figure 25. The pulser, receiver, diplexer, and communication boards were mounted and integrated on a frame (E-cage) inside the Electronics Module. During this integration, some grounding and noise issues were identified and solved. The full subassembly (Sensor and Electronics Modules) is shown in Figure 26.

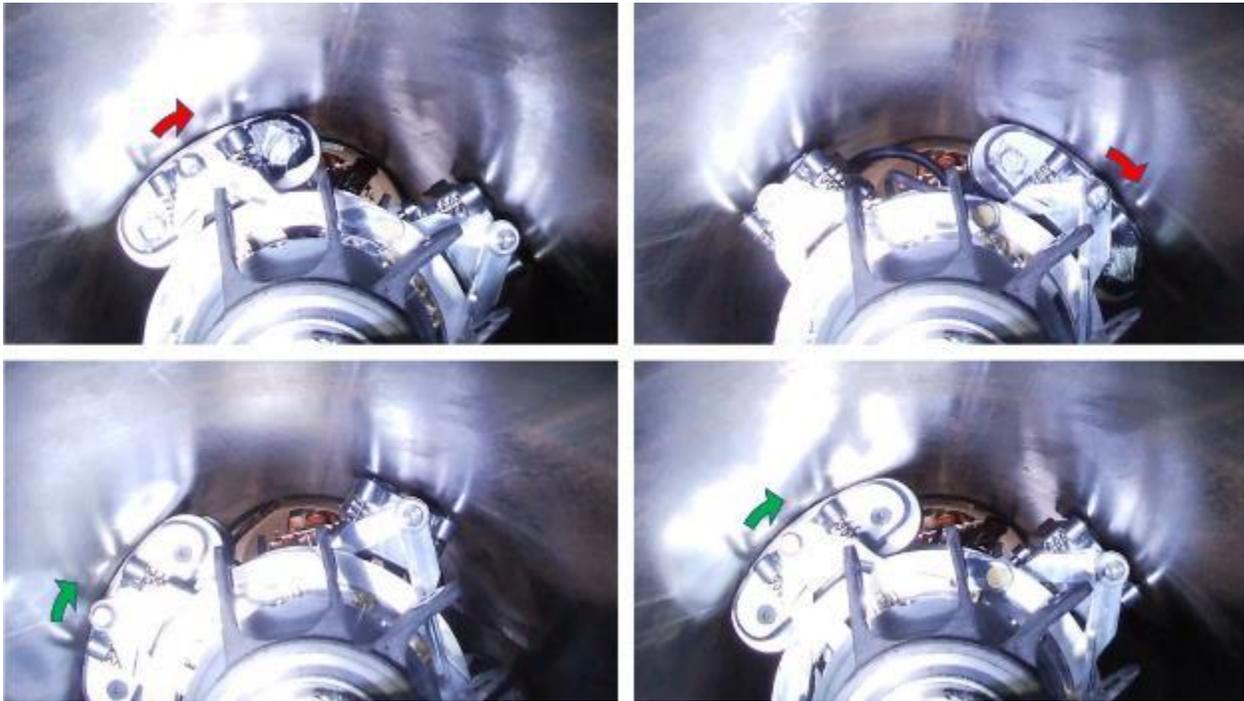
Figure 27. Rotor Scanner with EMAT Sensors Inside a Pipe

Some views of the scanner inside the pipe and with the EMAT sensors under rotation are shown in Figure 27. The red arrows are for sensor #1 and the green arrows for sensor #2. Sensor #1 and #2 are placed 180 deg apart. It can be observed that during the scan, the EMAT sensors maintained a full contact against the pipe surface. Acoustic responses were gathered with the on-board electronics for both channels and typical A-Scans for are depicted in Figure 28. The sensors were able to gather multiple reflections (wall echoes) from the pipe. To assess the 360deg inspection, the sensors scanned an ERW pipe with two fabricated wall loss flaws. Thus, B-Scans were produced for both sensors and are presented in Figure 29. On this figure, the ERW zone as well as the flaws are clearly observed!

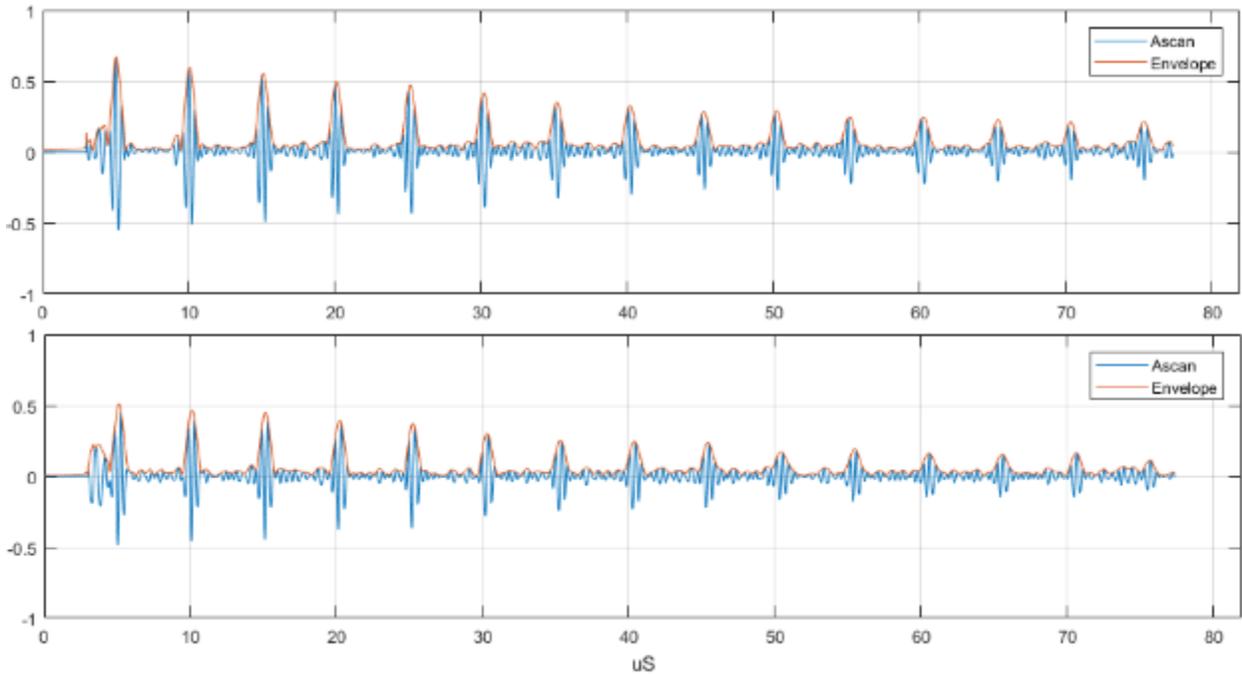
Figure 28. A-Scan of EMAT Sensors 1 and 2 at ping #5.

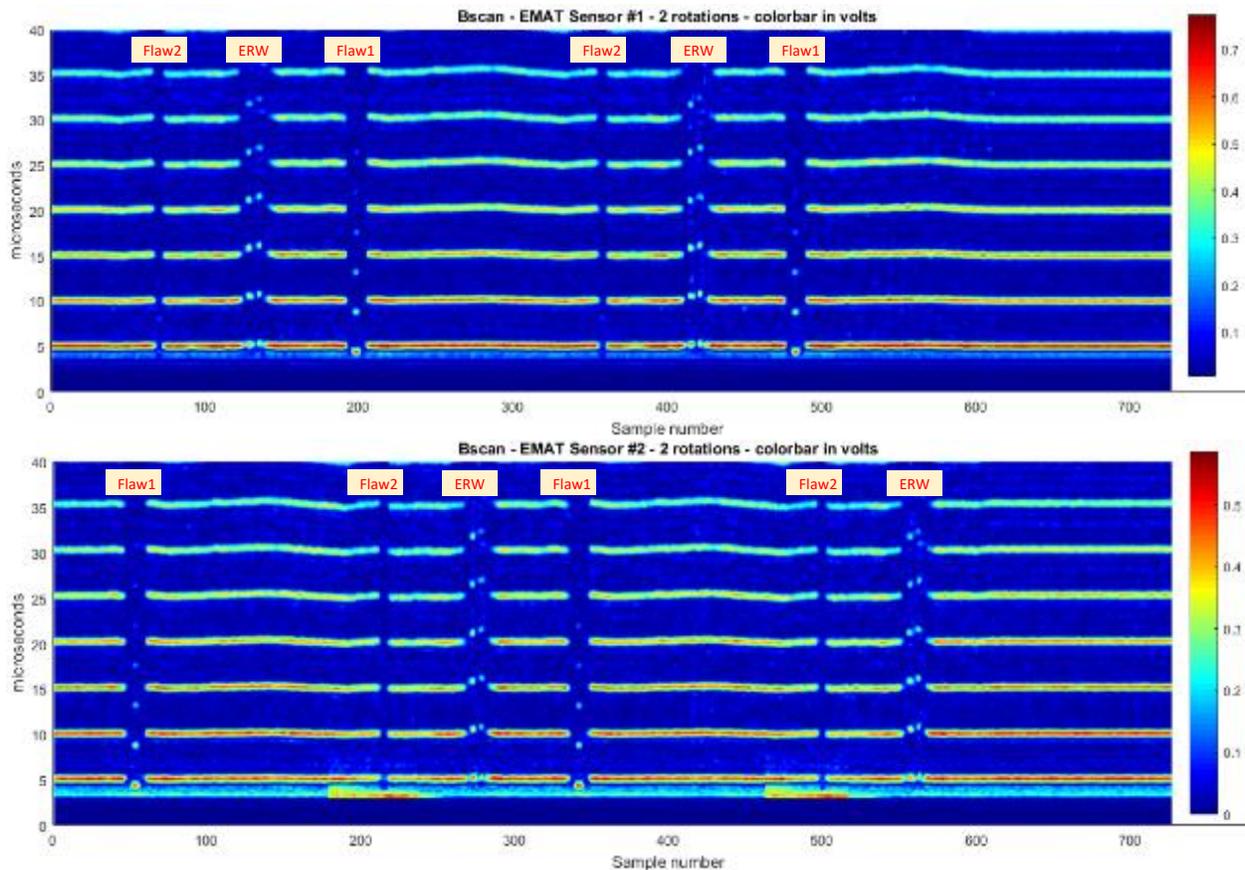
Figure 29. B-Scans for EMAT Sensors 1 (top) and 2 (bottom) Showing Pipe Features

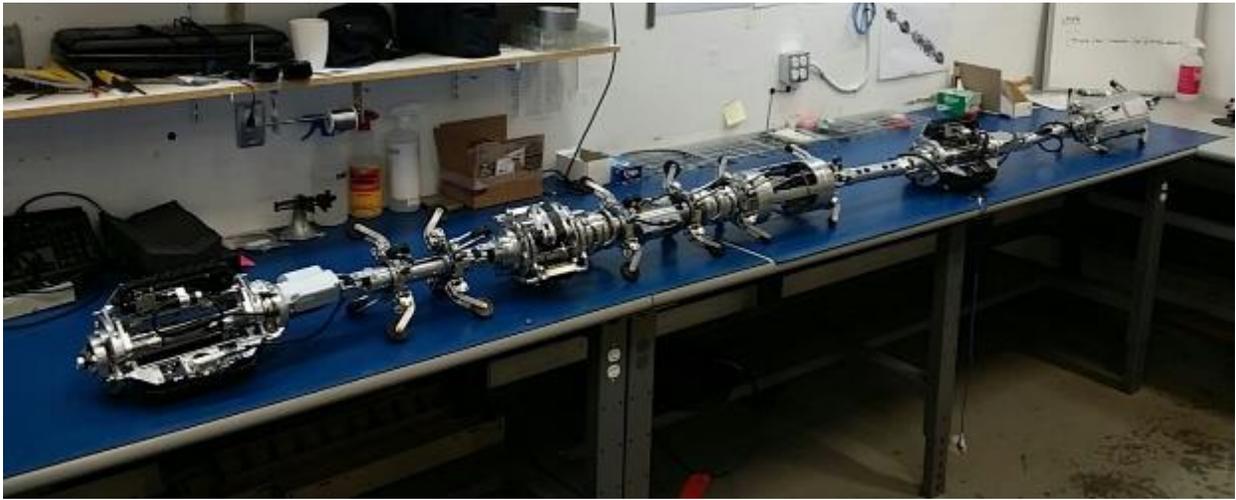
Figure 30. EMAT/Wall Loss tool
